120TH AVENUE CORRIDOR STUDY: EXISTING CONDITIONS

April 2024

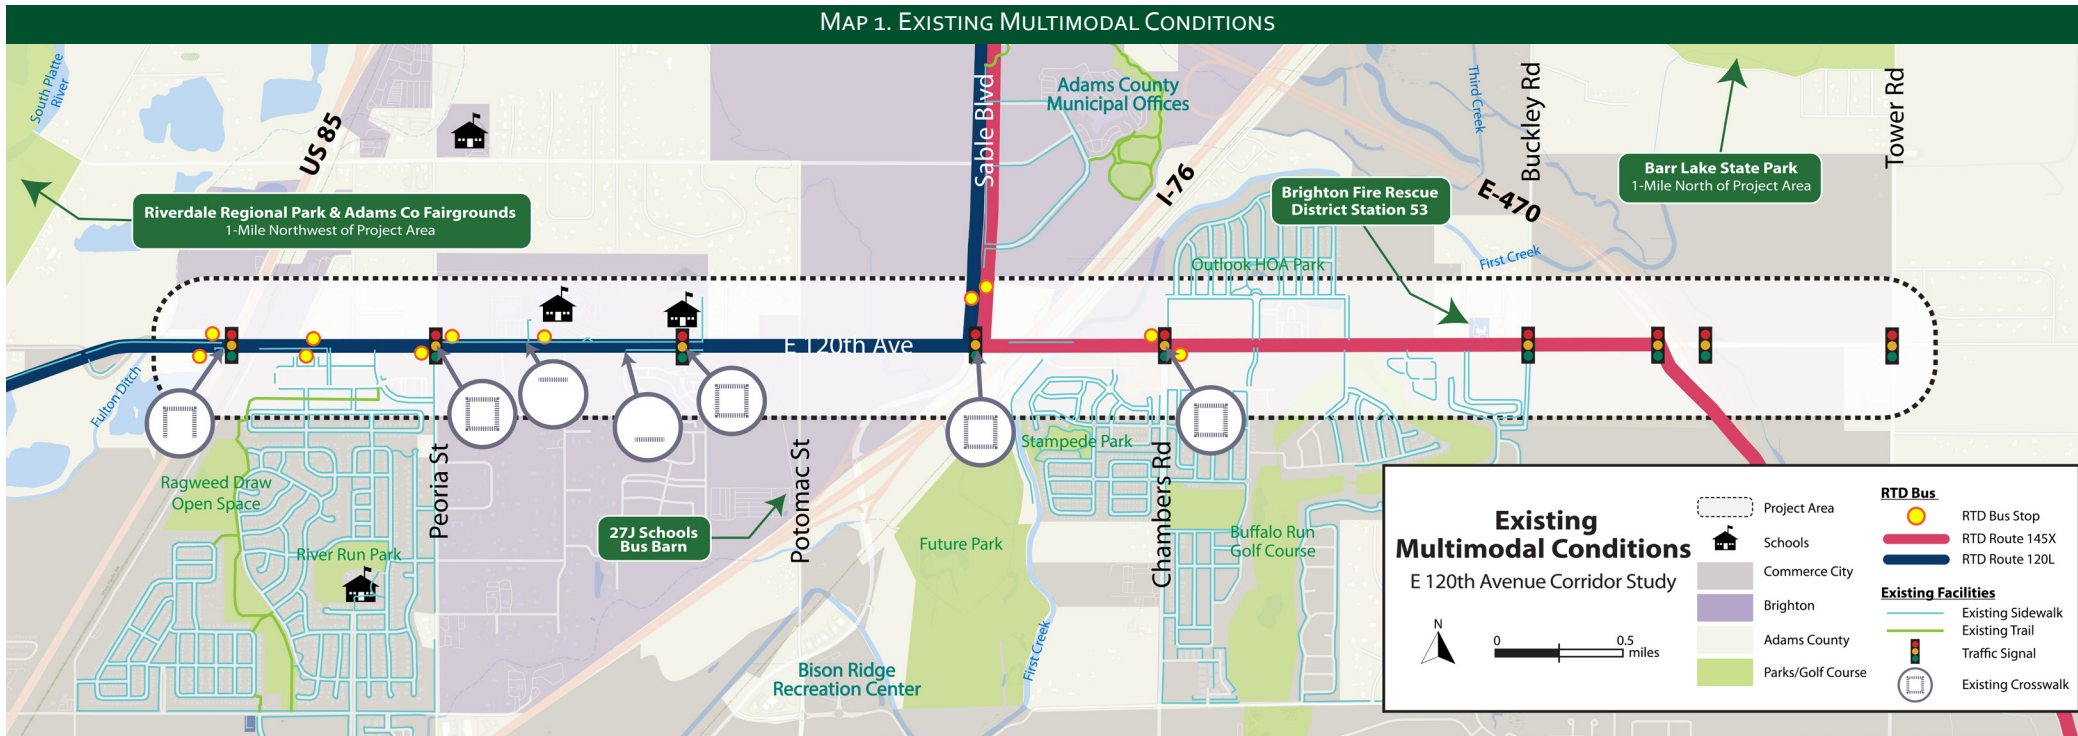
MAP 1. EXISTING MULTIMODAL CONDITIONS

A majority of the E 120th Avenue corridor between Highway 85 and Tower Road does not have paved sidewalks. For the most part, pedestrians must use the shoulder to walk along the corridor and, in many cases, these areas have not been improved (with sidewalks) and are not compliant with the Americans with Disabilities Act (ADA). The project area stretches a total of 4.6-miles from Highway 85 to Tower Road. If sidewalks were continuous on both sides of 120th Avenue, that would equate to approximately 9-miles of sidewalk. However, there is currently only 1.33-miles of sidewalk, which equates to just 15% of the corridor. The segments of E 120th Avenue that do have sidewalks are those where newer development has occurred within the last 10 years. All existing sidewalks are six to ten feet wide and are generally in good condition.

Map 1 shows the limited extents of sidewalk on the project corridor. As shown, there are just a few segments of sidewalk that currently exist. The first is a section on the north side of 120th Avenue, just west of Highway 85, and it is a ten-foot concrete sidewalk in good condition. Only a small portion of this sidewalk segment is located within the project corridor, but as seen on the map, the sidewalk does continue west. There is also a short segment of sidewalk on the south side of 120th Avenue, just east of Havana Street, which extends to Moline Street. This sidewalk segment is a six-foot wide, ADA compliant sidewalk, buffered by a ten-foot landscaping strip. The longest sidewalk segment along the corridor is on the north side of 120th Avenue between Peoria Street and Prairie View Middle School. It starts as a ten-foot asphalt sidewalk at Peoria Street and continues

as a combination of detached and attached sidewalk before ending just to the east of the Prairie View Middle School parking lot. This sidewalk is also in good condition and is buffered with a four-foot landscaping strip. The next segment is a short sidewalk segment on the south side of 120th Avenue, which starts at Foley Road and ends just a short way past the Prairie View Middle School intersection. This sidewalk is a newer ten-foot wide sidewalk, in good condition, and is buffered by a large landscaping strip. The last sidewalk segment on the corridor is located on the north side of 120th Avenue where the road passes over I-76. This sidewalk is difficult to access because of the road guardrail on both ends of the segment. The guardrail prevents pedestrians from being able to access the sidewalk without climbing over it (see Figure 1). Both ends of the sidewalk segment are also overrun with weeds and lack connections to

a continuous sidewalk or path. Overall, the sidewalk concrete is in good condition, but it clearly has barriers to be able to comfortably access it.

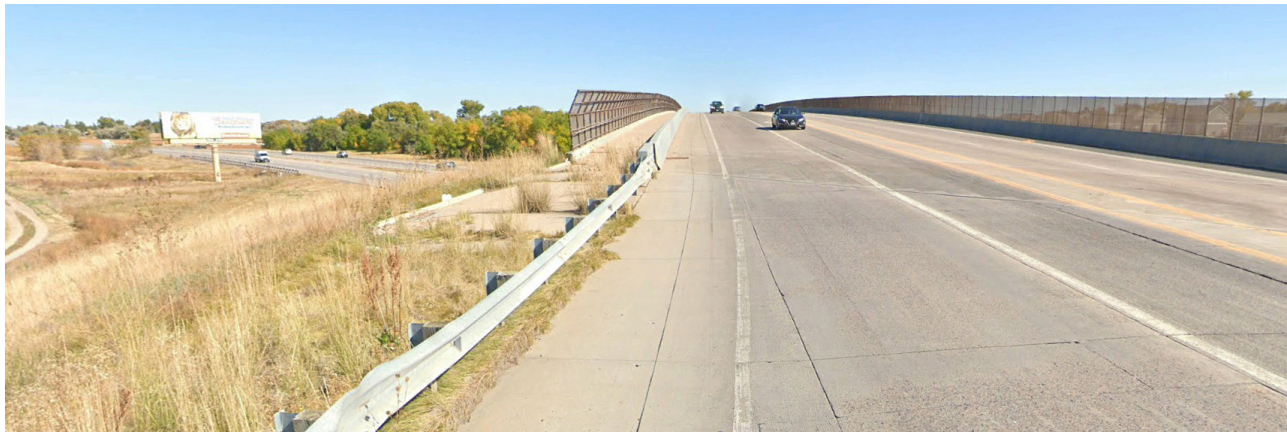
FIGURE 1. SIDEWALK OVER I-76 RESTRICTED BY GUARDRAILS AND LACKING CONNECTIVITY AT BOTH ENDS

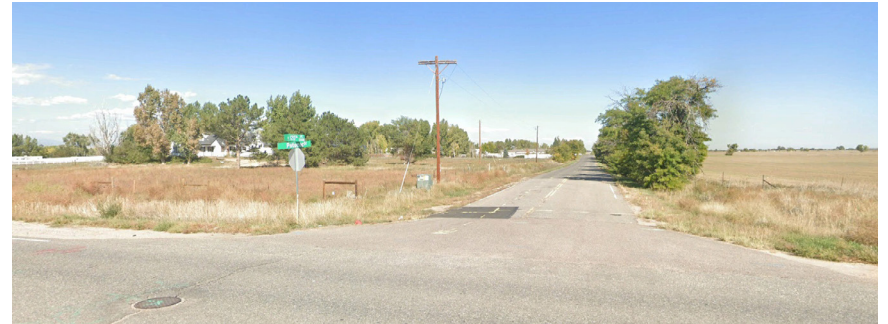
sidewalks or intersection curb ramps (see Figure 2). At other intersections, there are ramps that are partially but not fully compliant with ADA requirements. There are also curb ramps that are ADA compliant, but do not connect to an adjacent crosswalk or sidewalk (see Figure 3). In other locations, such as those in front of the Prairie View Middle School, curb ramps are fully ADA compliant and connect to ADA accessible sidewalks (see Figure 4).

FIGURE 2. POTOMAC/120TH - EXAMPLE OF WHAT IS MOST TYPICALLY SEEN ALONG THE CORRIDOR WITH NO CURB RAMPS OR CONNECTIONS TO SIDEWALKS OR CROSSWALKS.

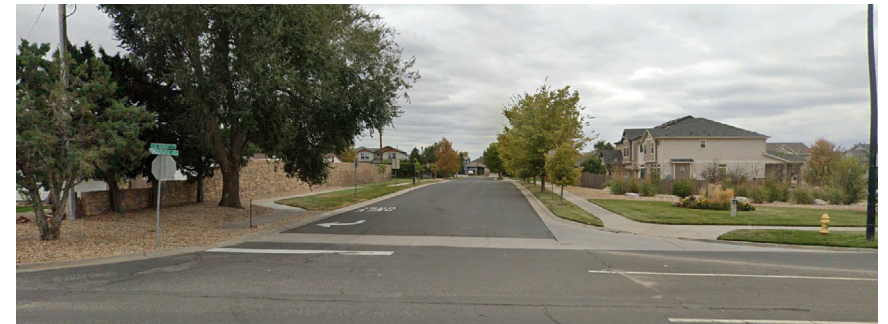
FIGURE 3. MOLINE/120TH – INCOMPLETE CURB RAMP WITH ADA COMPLIANCE ON ONE SIDE BUT NO CONNECTION TO SIDEWALK ON ADJACENT SIDE.

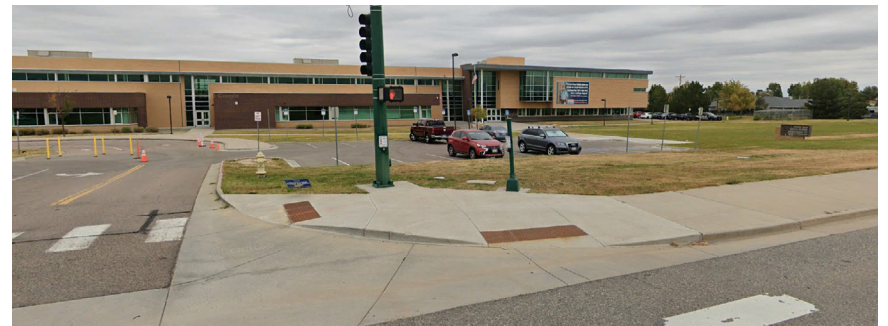
FIGURE 4. SOUTHGATE INTERSECTION - COMPLETE AND ADA COMPLIANT CURB RAMPS.

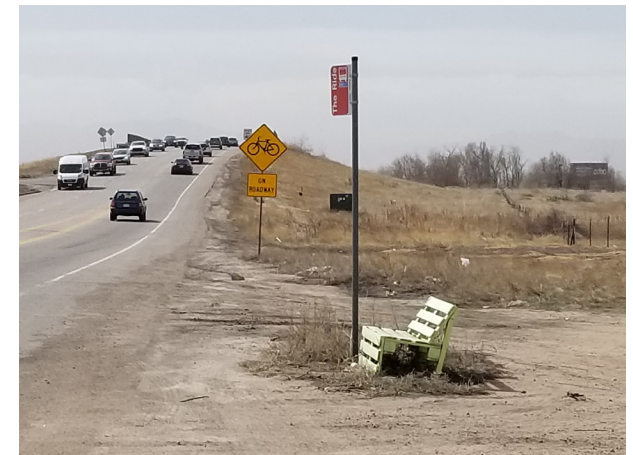
FIGURE 5. EXISTING BUS STOP ON 120TH AVENUE JUST WEST OF CHAMBERS ROAD.

Ridership numbers for Routes 120L and 145X are currently low but are expected to increase as development continues along and near the corridor. Currently, bus stops for the 120L and 145X lines lack facilities such as benches and waiting enclosures. In addition, most of the stops that are not ADA compliant are located on a dirt shoulder next to the road, do not have sidewalk connections to the stops, and have limited separation from passing vehicles. An example of an existing stop is shown in Figure 5. The lack of facilities and accessibility are likely key reasons for the low ridership.

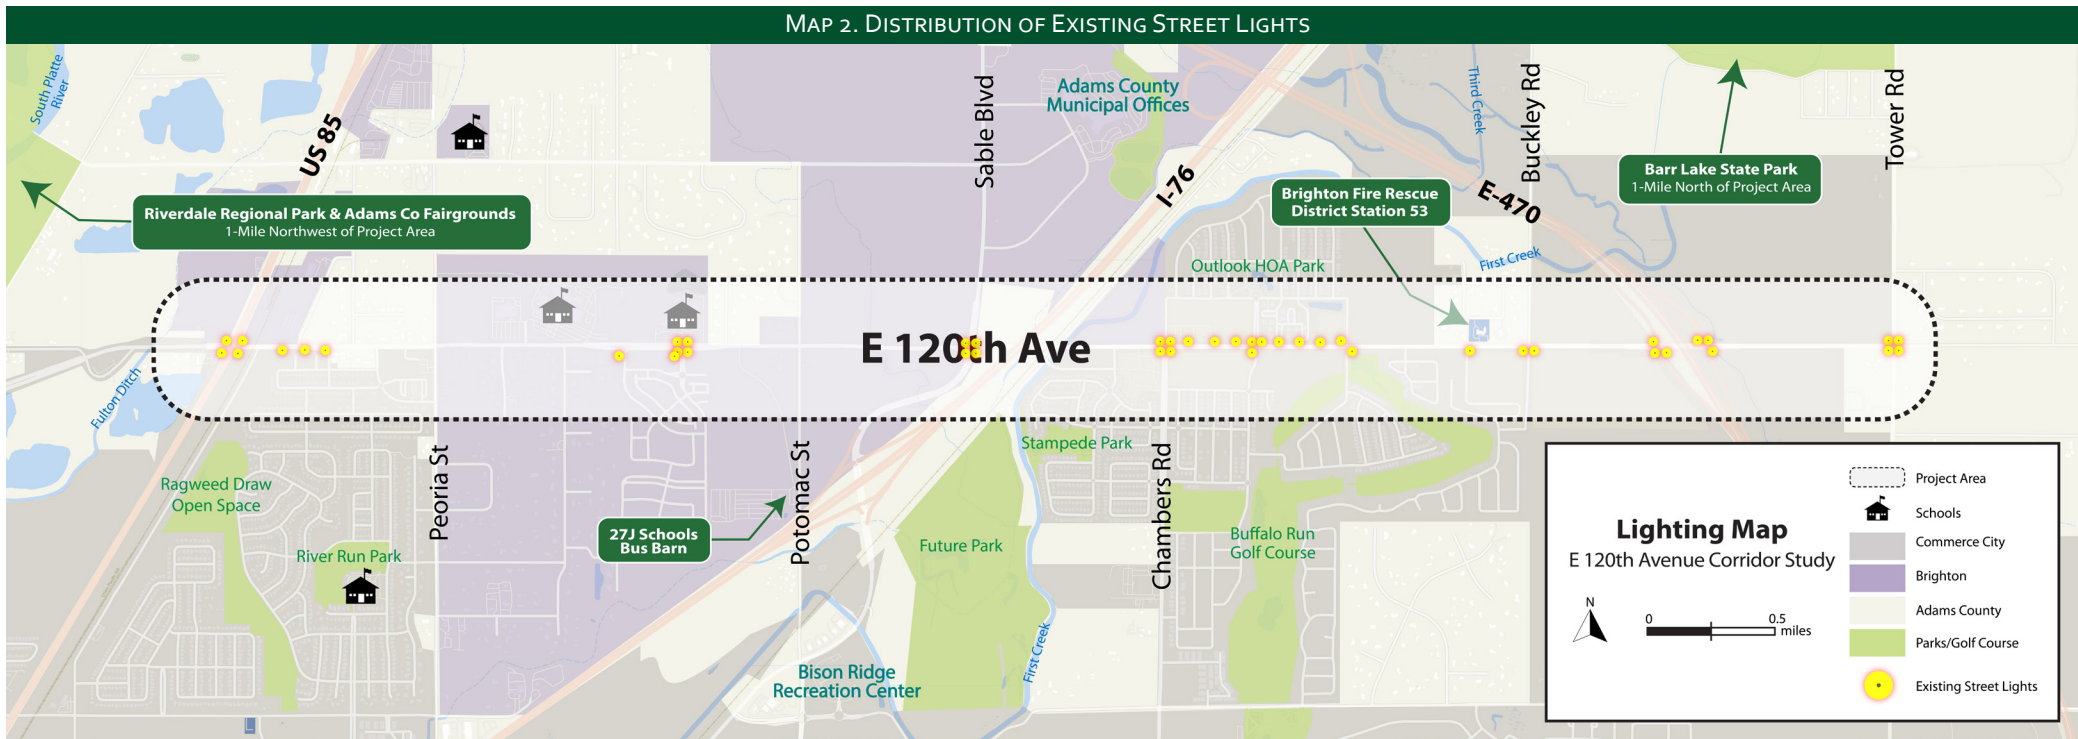
MAP 2. DISTRIBUTION OF EXISTING STREET LIGHTS

The existing roadway lighting on 120th Avenue between US 85 and Tower Road is minimal and inconsistent. The current lighting system lacks lighting at decision points, such as entries and exits to the side roads of 120th Avenue. Without sufficient illumination at these decision points the safety and visibility for motorists and pedestrians is decreased. The current lighting layout also lacks uniformity, as some sections of 120th Avenue have ample lighting, while other sections have none. The overall lighting design goal should be to provide continuous uniform illumination along 120th Avenue in compliance with local and state lighting design requirements.

Map 2 shows the location of existing lighting fixtures and demonstrates this inconsistency.
